## **APPENDIX M**

### **Compensatory Mitigation Plan**

## MEMORANDUM

**Re:** Compensatory Mitigation Plan – Identified Revisions Planned

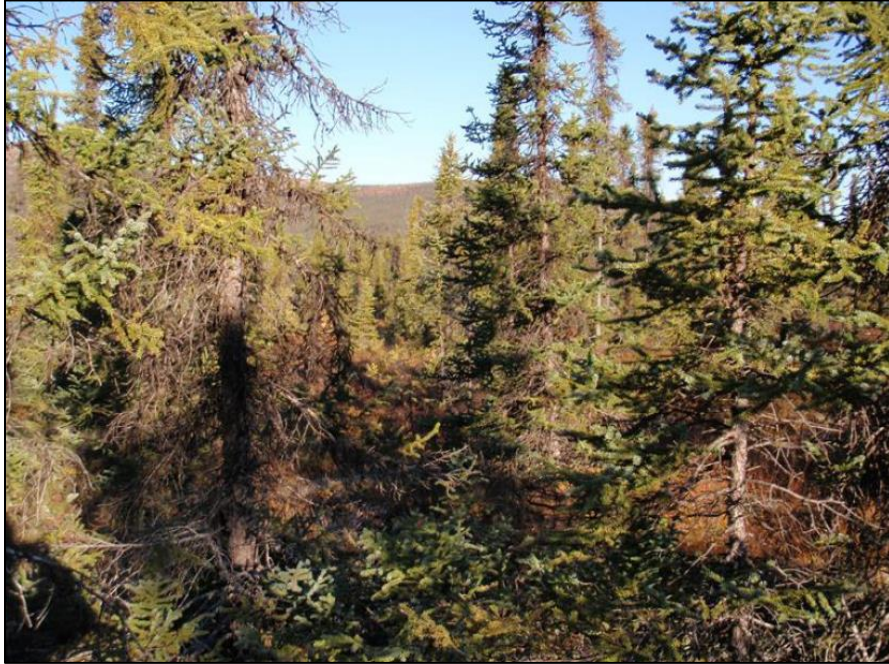
*Photo 1      Open Black Spruce Forest Vegetation Type*

Wetlands in the MA are dominated by Open Black Spruce Forest (OBSF) and Black Spruce Woodland (BSW) vegetation types. OBSF is characterized by the presence of an open canopy of trees and saplings dominated by black spruce (*Picea mariana*), with a predominantly ericaceous shrub understory. Understory species commonly found in both upland and wetland OBSF plots include alpine blueberry (*Vaccinium uliginosum*), marsh Labrador-tea (*Rhododendron tomentosum*), black crowberry (*Empetrum nigrum*), swamp birch (*Betula nana*), northern mountain-cranberry (*Vaccinium vitis-idaea*), Bigelow's sedge (*Carex bigelowii*), woodland horsetail (*Equisetum sylvaticum*), and cloudberry (*Rubus chamaemorus*). Typical Cowardin Classifications (Cowardin et al. 1979) include PFO4/SS1B and PSS4/SS1B (Photo 1) (Michael Baker 2016).

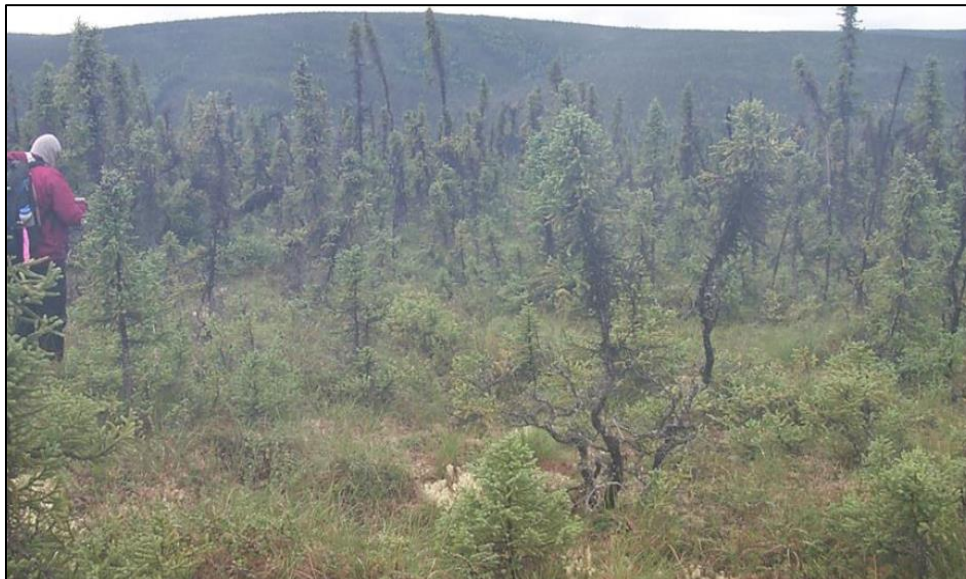
*Photo 2      Black Spruce Woodland Vegetation Type*

The BSW vegetation type is characterized by a sparse canopy (cover, 10 to 25-percent) of trees and saplings dominated by black spruce. Dominant understory species are typically the same as for OBSF. Typical Cowardin Classifications include PSS1/FO4B and PSS1/4B (Photo 2) (Michael Baker 2016).

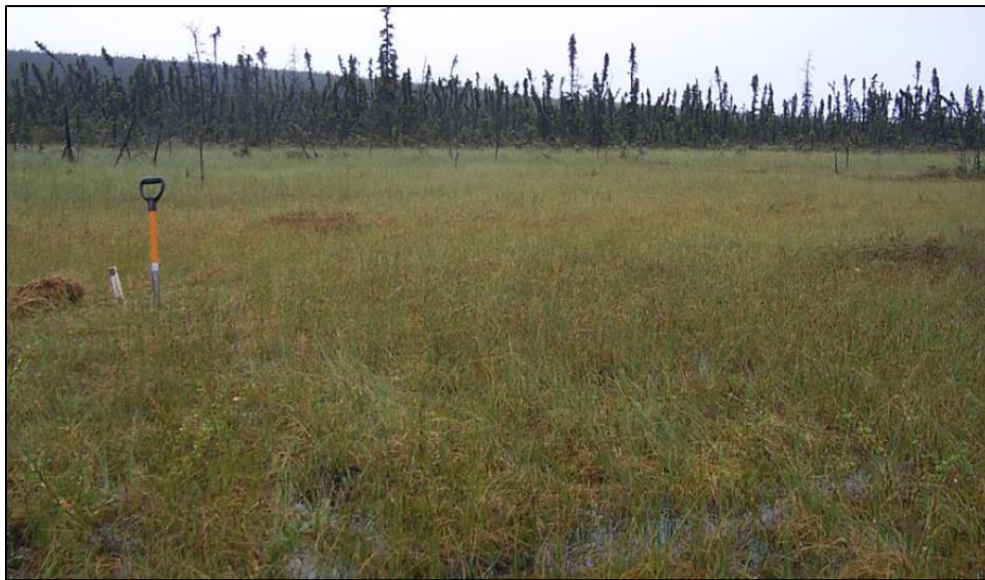
Photo 3      *Wet Herbaceous Vegetation Type*

The dominant source of water for post-disturbance restored wetlands in areas with cut and fill disturbance will be groundwater (Slope Hydrogeomorphic classification). These areas are expected to be dominated by the Wet Herbaceous vegetation type. This vegetation type is characterized by a sparse canopy of tree and saplings (cover, less than 10-percent), and an overall shrub cover of less than 25-percent (Photo 3). Dominant species for this vegetation type in the Crooked Creek watershed include leafy tussock sedge (*Carex aquatilis*), pumpkin-fruit sedge (*Carex rotundata*), purple marshlocks (*Comarum palustre*), water horsetail (*Equisetum fluviatile*), cottongrass (*Eriophorum* spp.), and bluejoint (*Calamagrostis canadensis*). These plots typically have a Cowardin Classification of PEM1C (Michael Baker 2016).

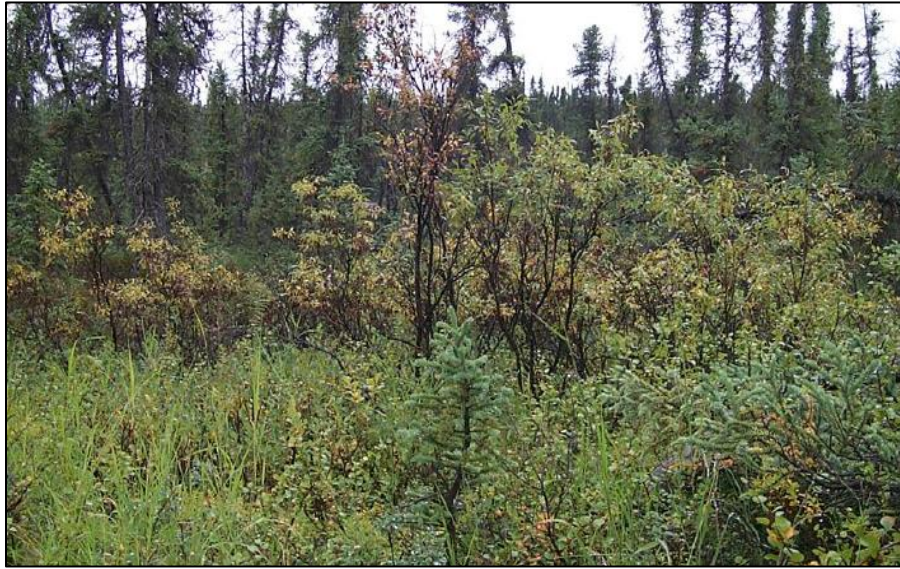
*Photo 4      Open Alder Willow Shrub Vegetation*

Areas flooded by the Snow Gulch freshwater reservoir are expected to restore as Open Alder Willow Shrub (OAWS) and Open Willow Shrub (OWS) vegetation types. Species commonly found in wetland OAWS plots include speckled alder (*Alnus incana*), Sitka/green Alder (*Alnus viridus*), diamond-leaf willow (*Salix pulchra*), Steven's Meadowsweet (*Spiraea stevenii*), alpine blueberry, and bluejoint (Photo 4). Species commonly found in wetland OWS plots include several species of willow depending on landscape position, including diamond-leaf willow, felt-leaf willow (*Salix alaxensis*), and little-tree willow (*Salix arbusculoides*). Understory shrubs include swamp birch and alpine blueberry. Understory herbaceous species include bluejoint and purple marshlocks (Photo 5). Typical Cowardin Classifications for OWS and OAWS are PSS1 and PSS1/EM1 with an A or C water regime (Michael Baker 2016).

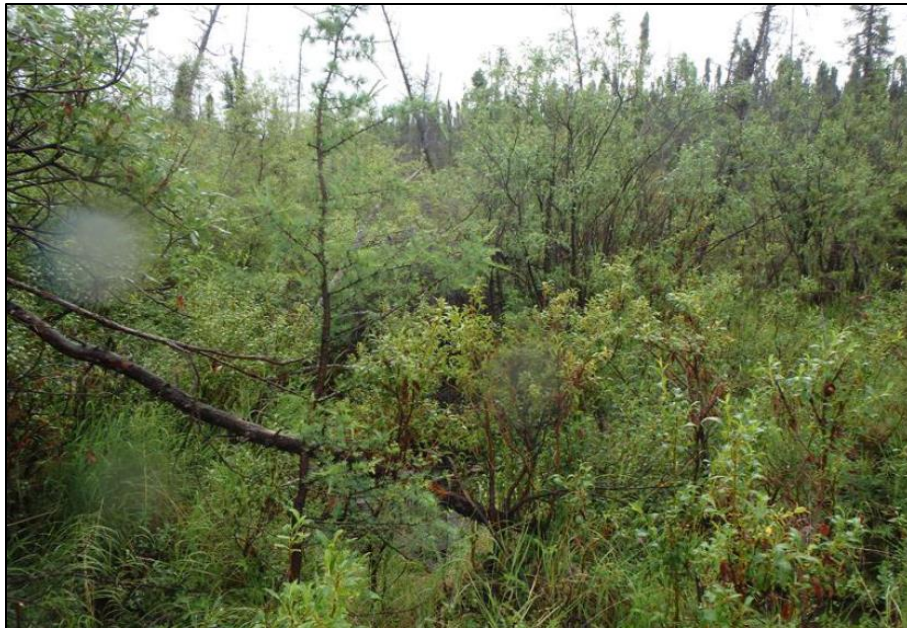
*Photo 5      Open Willow Shrub Vegetation*

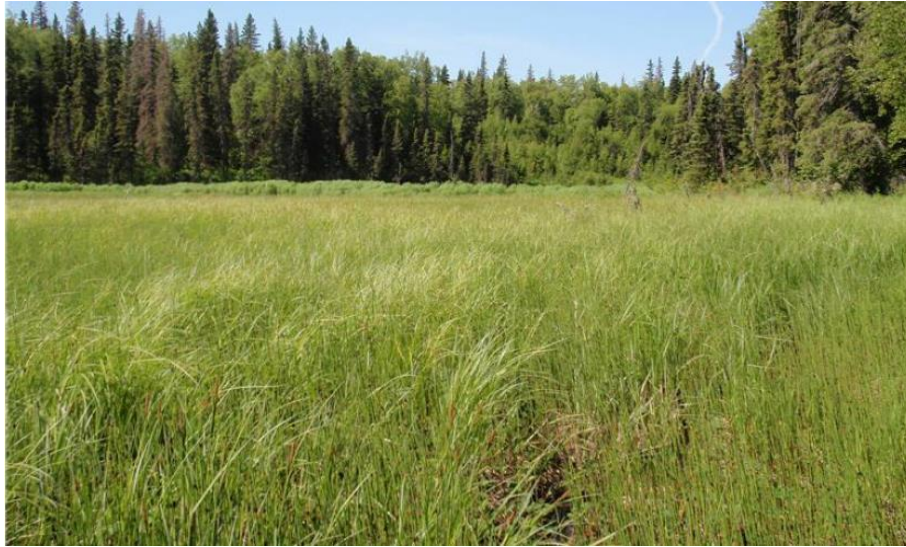
Photo 1      *Wet Herbaceous Vegetation, Theodore River HUC-10*

In the Cook Inlet Lowlands MLRA (Lower Skwentna River and Theodore River HUC-10s), WH plots are typically dominated by bluejoint, water horsetail, and a variety of sedges including Leafy Tussock Sedge, Montana Sedge (*Carex media*), and loose-flower alpine sedge (*Carex rariflora*) [Photo 1] (Michael Baker 2016).

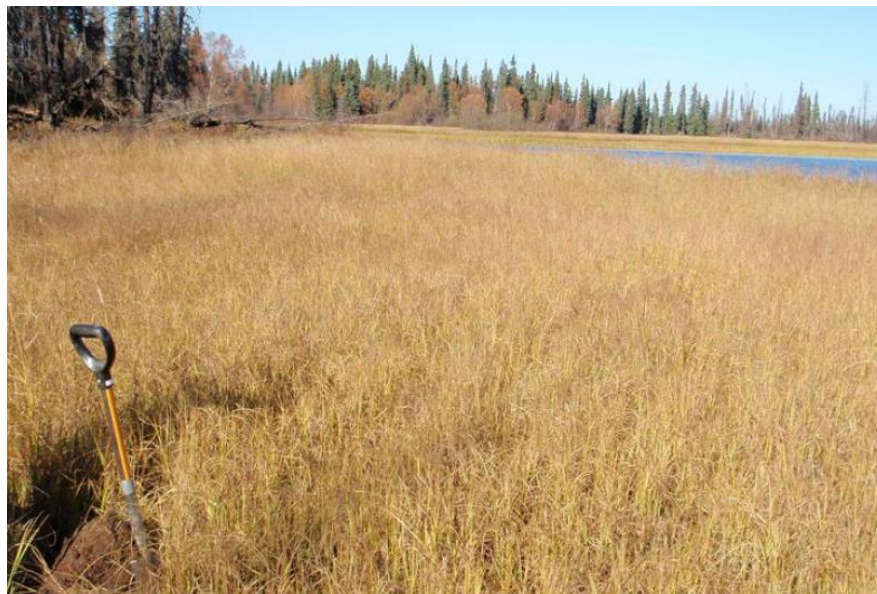
Photo 2      *Wet Herbaceous Vegetation, Middle Big River HUC-10*

In the Interior Alaska Lowlands MLRA (Headwaters Tatlawiksuk, Middle Big, and Windy Fork Middle Fork Kuskokwim Rivers HUC-10s), dominant vegetation in WH plots can include leafy tussock sedge and Russet-Bristle Cotton-Grass (*Eriophorum russeolum*). A variety of other sedges including Bigelow's sedge, mud sedge (*Carex limosa*), loose-flower alpine sedge, few-flower sedge (*Carex pauciflora*), and Northwest Territory sedge (*Carex utriculata*) can also be dominant (Photo 2) [Michael Baker 2016].

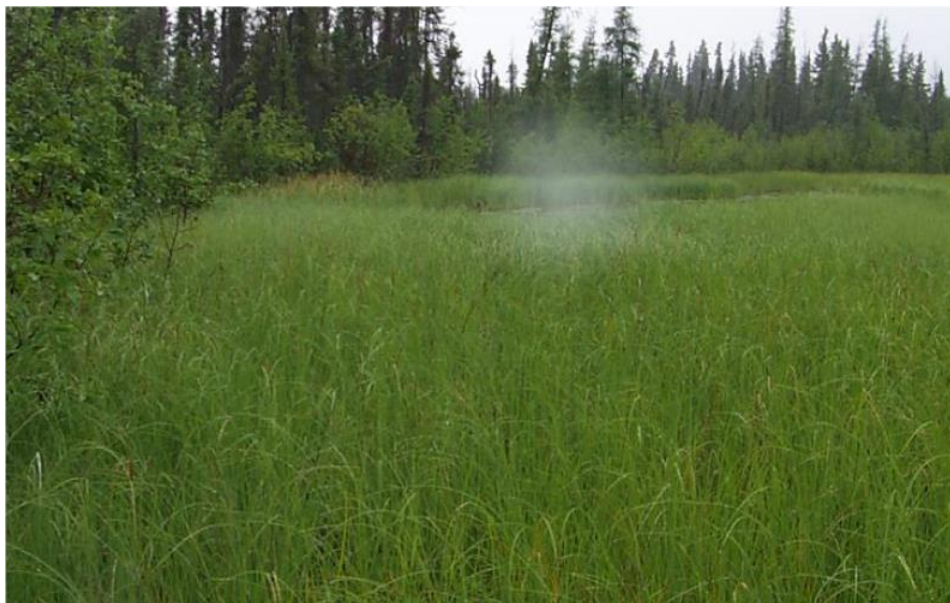
*Photo 3 Wet Herbaceous Vegetation, Crooked Creek HUC-10*

In the Yukon-Kuskokwim Highlands MLRA (Crooked Creek and Veahna Creek-Kuskokwim River HUC-10s), WH plots typically contain leafy tussock sedge, Northwest Territory sedge, bluejoint, and purple marshlocks as dominant plants (Photo 3) [Michael Baker 2016].

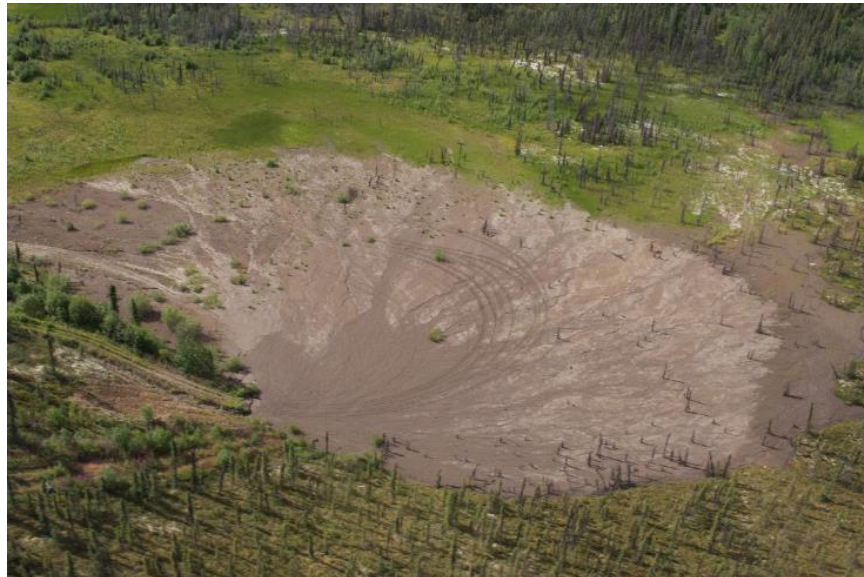
*Photo 1 Placer Mining Tailings Area (View Toward Northwest)*

Historical gold placer mining has occurred in the proposed restoration area and vicinity since the early 20<sup>th</sup> century. Placer tailings and overburden have been deposited in several locations within the various floodplains, causing adverse impacts to aquatic resources (Photo 1). Water diversion ditches were constructed resulting in the channeling of surface and shallow groundwater flow from the original stream paths. An estimated 8,700-linear feet (1.64-miles) of stream channels have been mined and the abutting wetlands degraded. No placer mining is currently ongoing in any of the drainages.

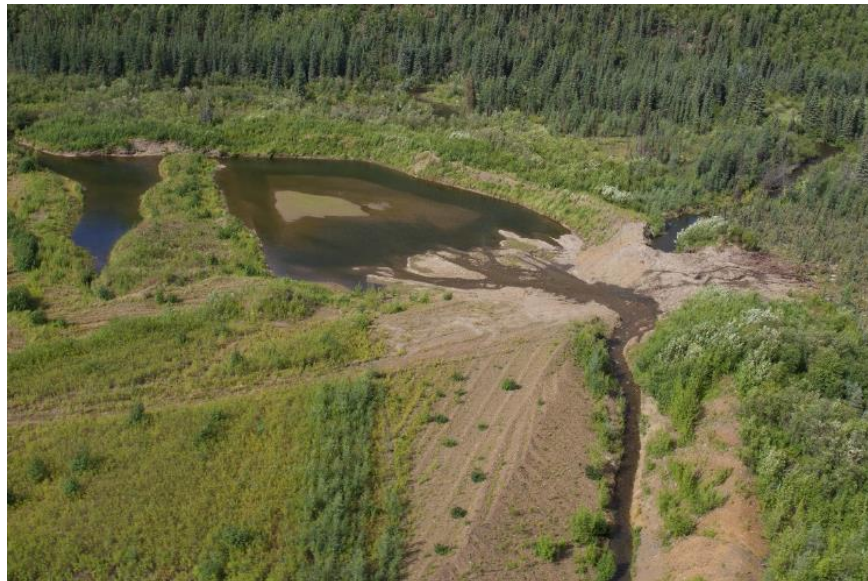
*Photo 2      Lower Snow Gulch Placer Disturbance (View Toward North)*

The site hydrology is controlled by Crooked Creek, Donlin Creek and the following drainages: Quartz Gulch (761-acres), Snow Gulch (2,183-acres), Ruby Gulch (303-acres), and Queen Gulch (458-acres). Quartz, Snow (Photo 2), Ruby, and Queen gulches (Photo 3) have been extensively degraded in their lower reaches from placer mining activity beginning in 1910.

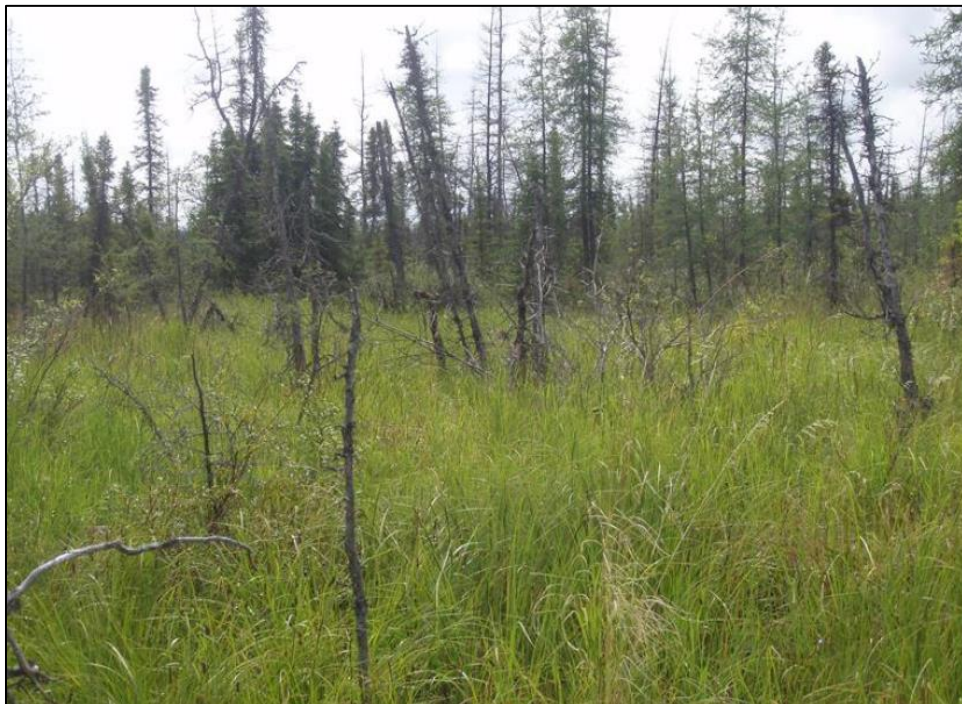
Photo 4      Wet Herbaceous Vegetation Type

- WH communities are typically dominated by hydrophytic herbaceous plants including bluejoint, leafy tussock sedge, purple marshlocks, cottongrass, and other sedges (*Carex spp.*). Total vegetative cover is typically greater than 70-percent (Photo 4).
- Species commonly found in wetland OAWS plots include speckled alder, Sitka/green Alder, diamond-leaf willow, Steven's Meadowsweet, alpine blueberry, and bluejoint. Total vegetative cover is typically greater than 90-percent (Photo 5).
- Species commonly found in wetland OWS plots include several species of willow depending on landscape position such as diamond-leaf willow, felt-leaf willow, and little-tree willow. Understory shrubs include swamp birch and alpine blueberry. Understory herbaceous species include bluejoint and purple marshlocks. Total vegetative cover is typically greater than 90-percent (Photo 6).

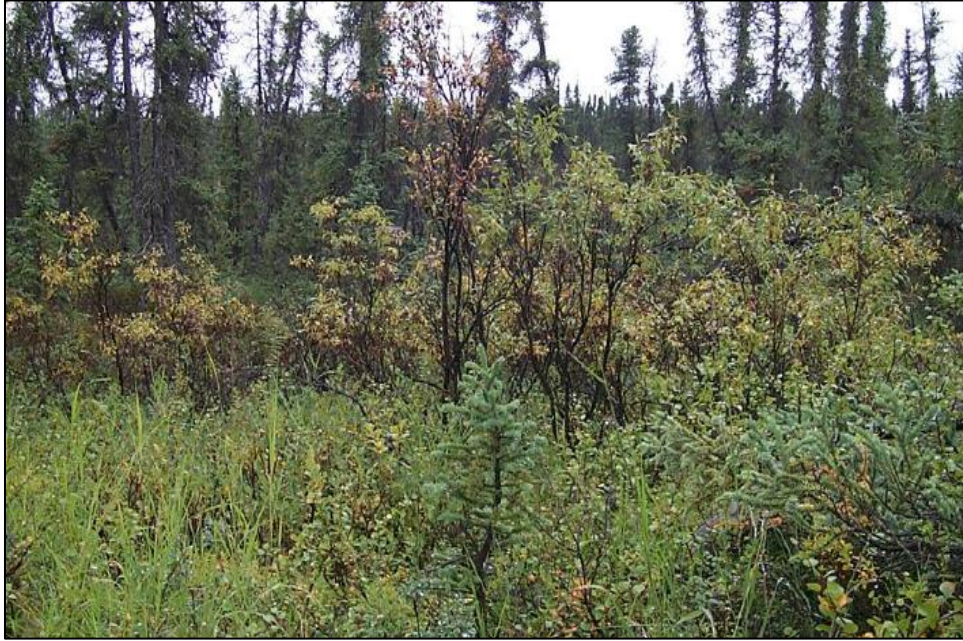
*Photo 5      Open Alder Willow Shrub Vegetation Type*

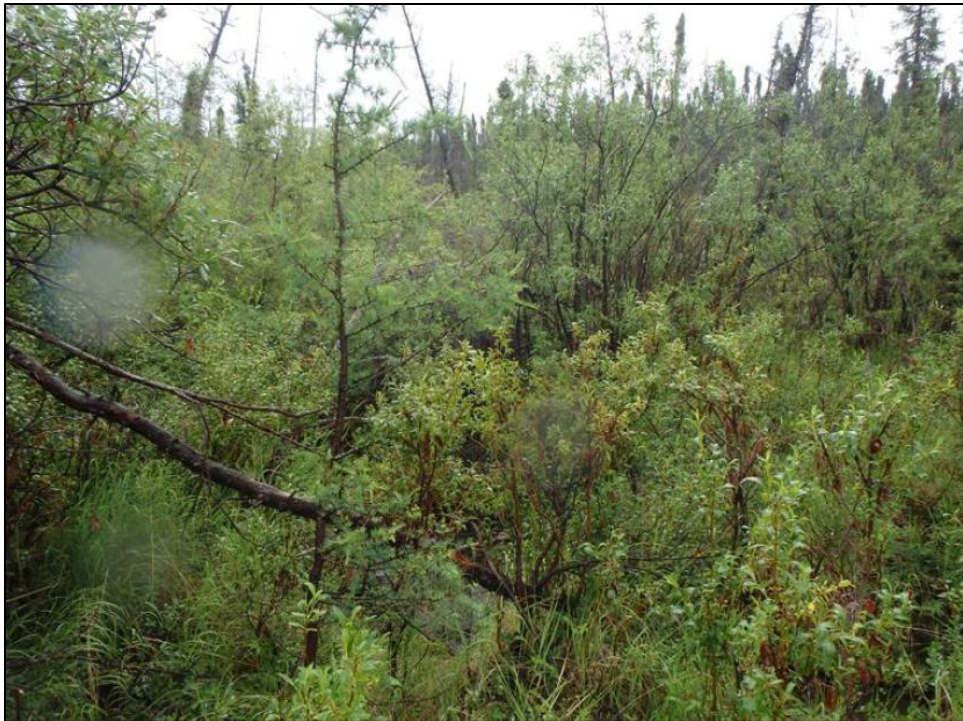
*Photo 6      Open Willow Shrub Vegetation Type*

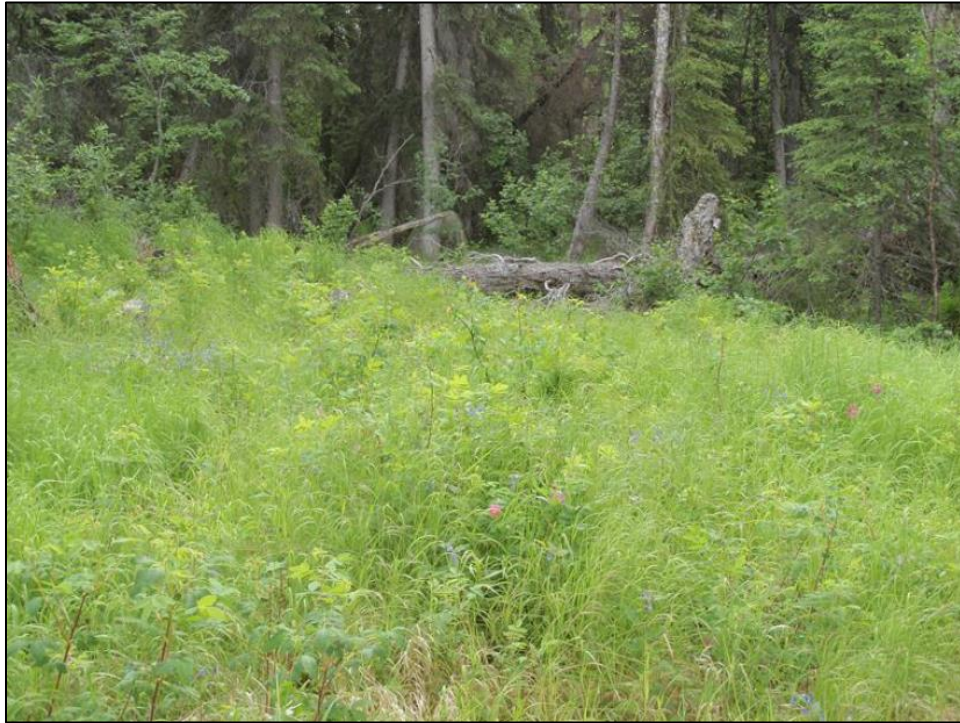
Photo 7      *Mesic Herbaceous Vegetation Type*

Baseline upland communities are Mesic Herbaceous (MH), OWS, and OAWS. Reference MH vegetation communities in the Crooked Creek watershed are typically dominated by bluejoint, with other herbaceous species mixed in, most commonly narrow-leaf fireweed (*Chamaenerion angustifolium*) (Photo 7). Total vegetative cover is typically greater than 90-percent. Upland OWS and OAWS have a similar vegetation composition to wetland sites of the same types, except purple marshlocks is not found in uplands.
